# Home Report

# Single Survey

| Property address | 3a Union Road<br>Bathgate<br>EH48 1NS |
| Date of inspection | 11/02/2025 |

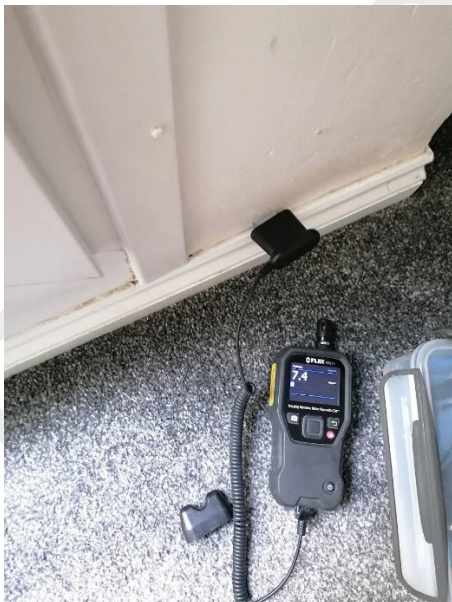
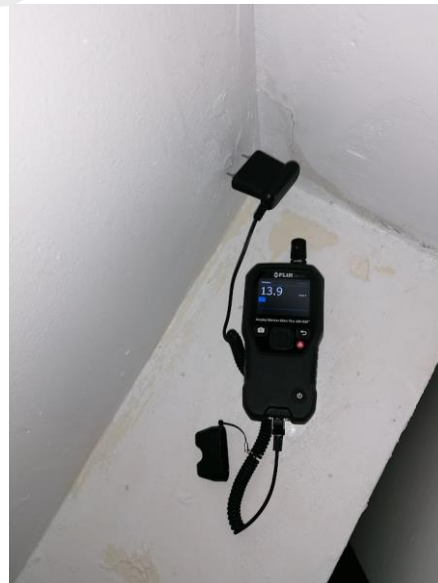
7% - 14% surface moisture condensation.

Notes: surface condensation, please see attached notes.

No chemical treatment required

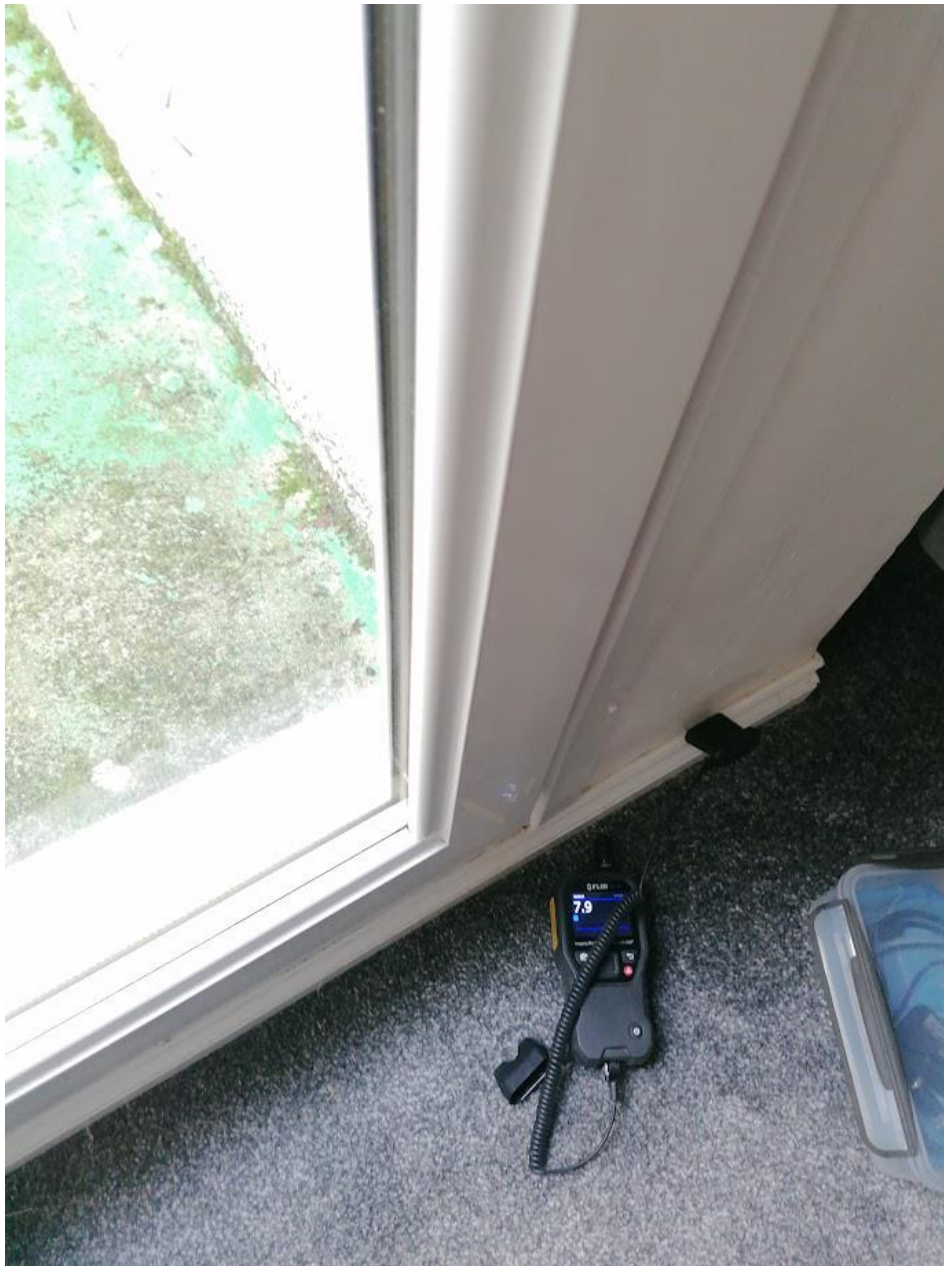
Condensation within the studded wall frame. Please see attached notes to help with humidity on cold wall surfaces.
