HOME REPORT

63 HEATHERBANK LADYWELL LIVINGSTON EH54 6EF

SINGLE SURVEY

survey report on:

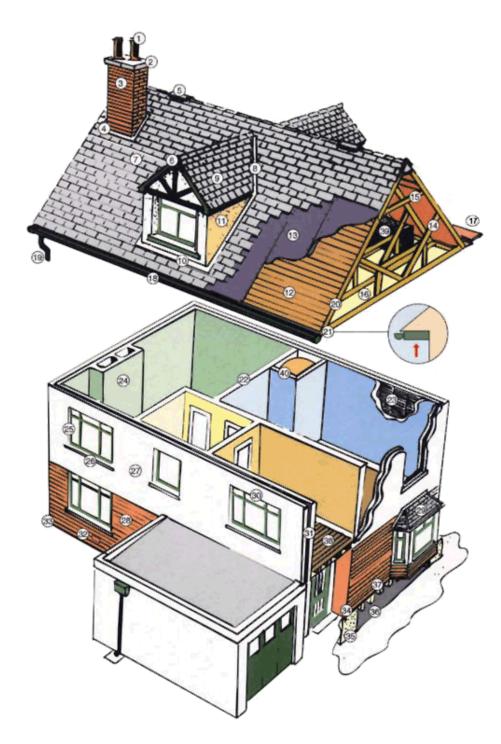
Sectional Diagram showing elements of a typical house

Reference may be made in this report to some or all of the above component parts of the property. This diagram may assist you in locating and understanding these items.

- 1) Chimney pots
- 2) Coping stone
- 3) Chimney head
- 4 Flashing
- 5 Ridge ventilation
- 6) Ridge board
- 7) Slates / tiles
- 8 Valley guttering
- Dormer projection
- 10) Dormer flashing
- 11) Dormer cheeks
- (12) Sarking
- (13) Roof felt
- (14) Trusses
- 15) Collar
- 16 Insulation
- (17) Parapet gutter
- (18) Eaves guttering
- (19) Rainwater downpipe
- 20) Verge boards /skews
- 21) Soffit boards
- 22) Partition wall
- 23) Lath / plaster
- (24) Chimney breast
- (25) Window pointing
- 6) Window sills
- 27) Rendering
- (28) Brickwork / pointing
- 29) Bay window projection
- 30 Lintels
- (31) Cavity walls / wall ties
- 32) Subfloor ventilator
- 33 Damp proof course
- 34) Base course
- (35) Foundations
- 36) Solum
- 37) Floor joists
- 38) Floorboards
- 39) Water tank
- 40 Hot water tank
